**Subject: Alleged "Structural Protection" of Jeep Grand Cherokee Fuel Tank System**  
**Reference: EA12-005 File Update**

**Subject:       Alleged “Structural Protection” of Jeep Grand Cherokee Fuel Tank System**  
**Reference:     EA12-005**

I am writing to inform you of recent investigation activity I have conducted, which is prompted in-part by public/private statements made and testimony offered by Chrysler defense counsel, Chrysler dealership defense counsel, existing and former Chrysler employees, and various Chrysler product liability defense experts. These statements and testimony have alleged in a general sense that the “structure” in the rear of the Jeep Grand Cherokee offers crashworthiness to the rear-mounted, polyethylene fuel tank system. My investigation concentrated on the 1993-1998 ZJ-Body of the Jeep Grand Cherokee, but the following can also be applied to the 1999-2004 WJ-Body version; both of which are a portion of the referenced NHTSA engineering analysis.

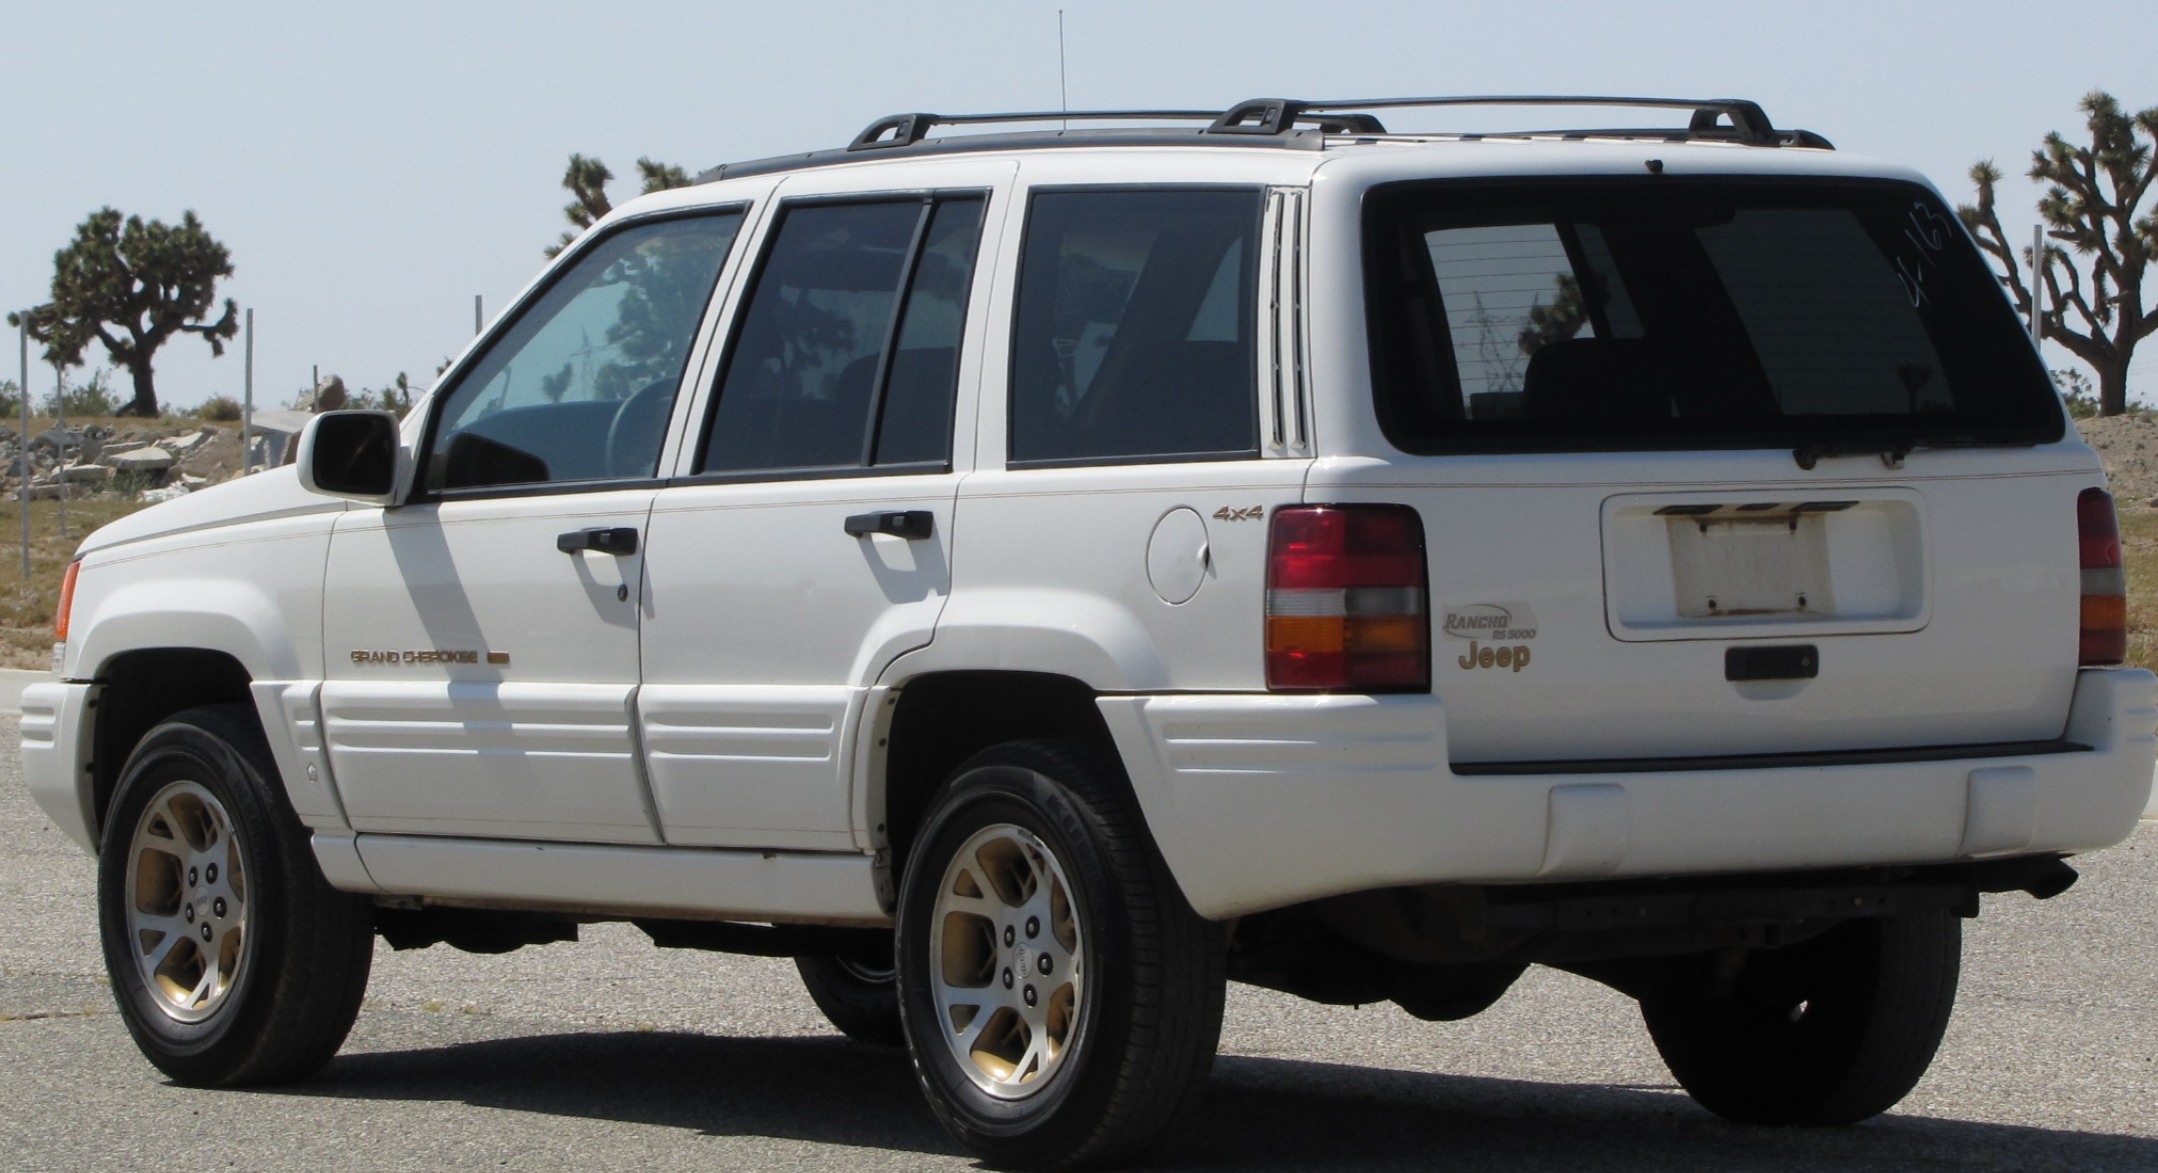
**ZJ-Body Jeep Grand Cherokee:  
Typical Customer View (of Fuel Tank)**

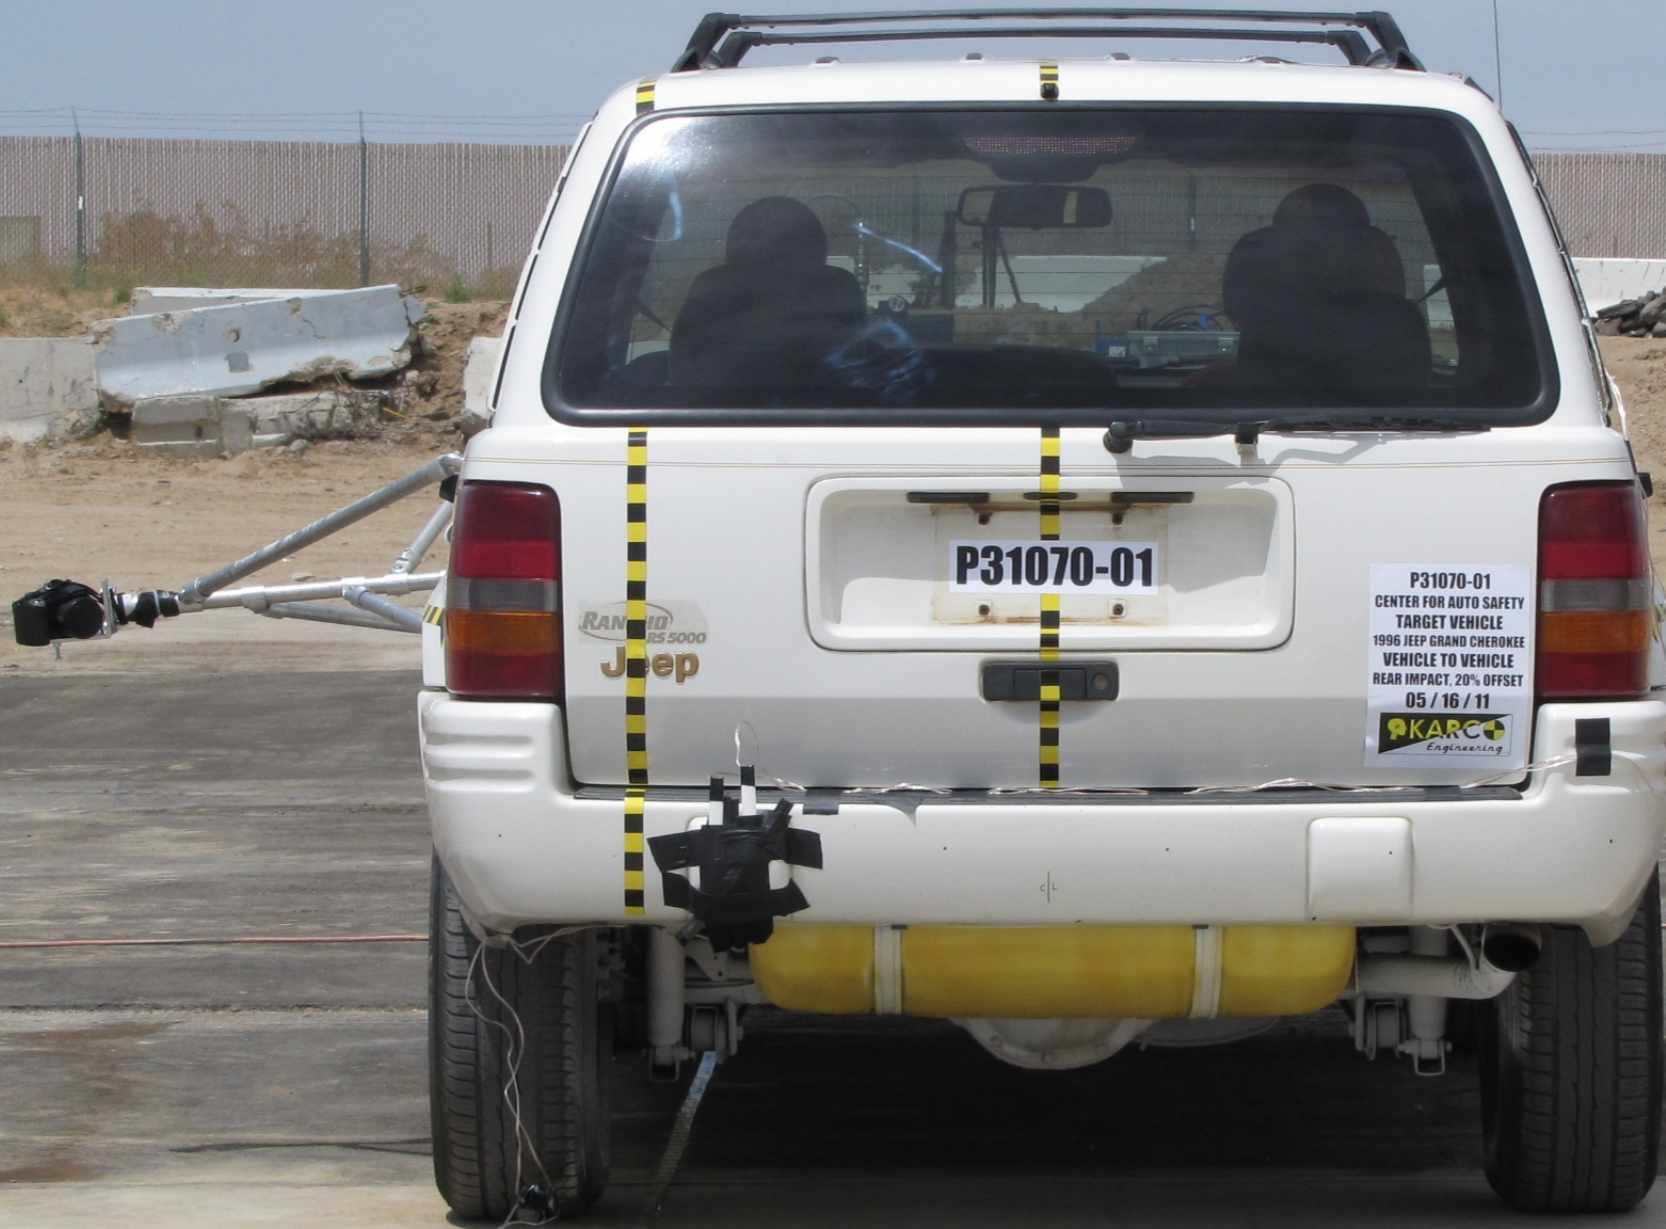
**ZJ-Body Jeep Grand Cherokee:  
What Showroom Customer Would See if  
Fuel Tank was not colored to match rear  
underbody / rear suspension components.**

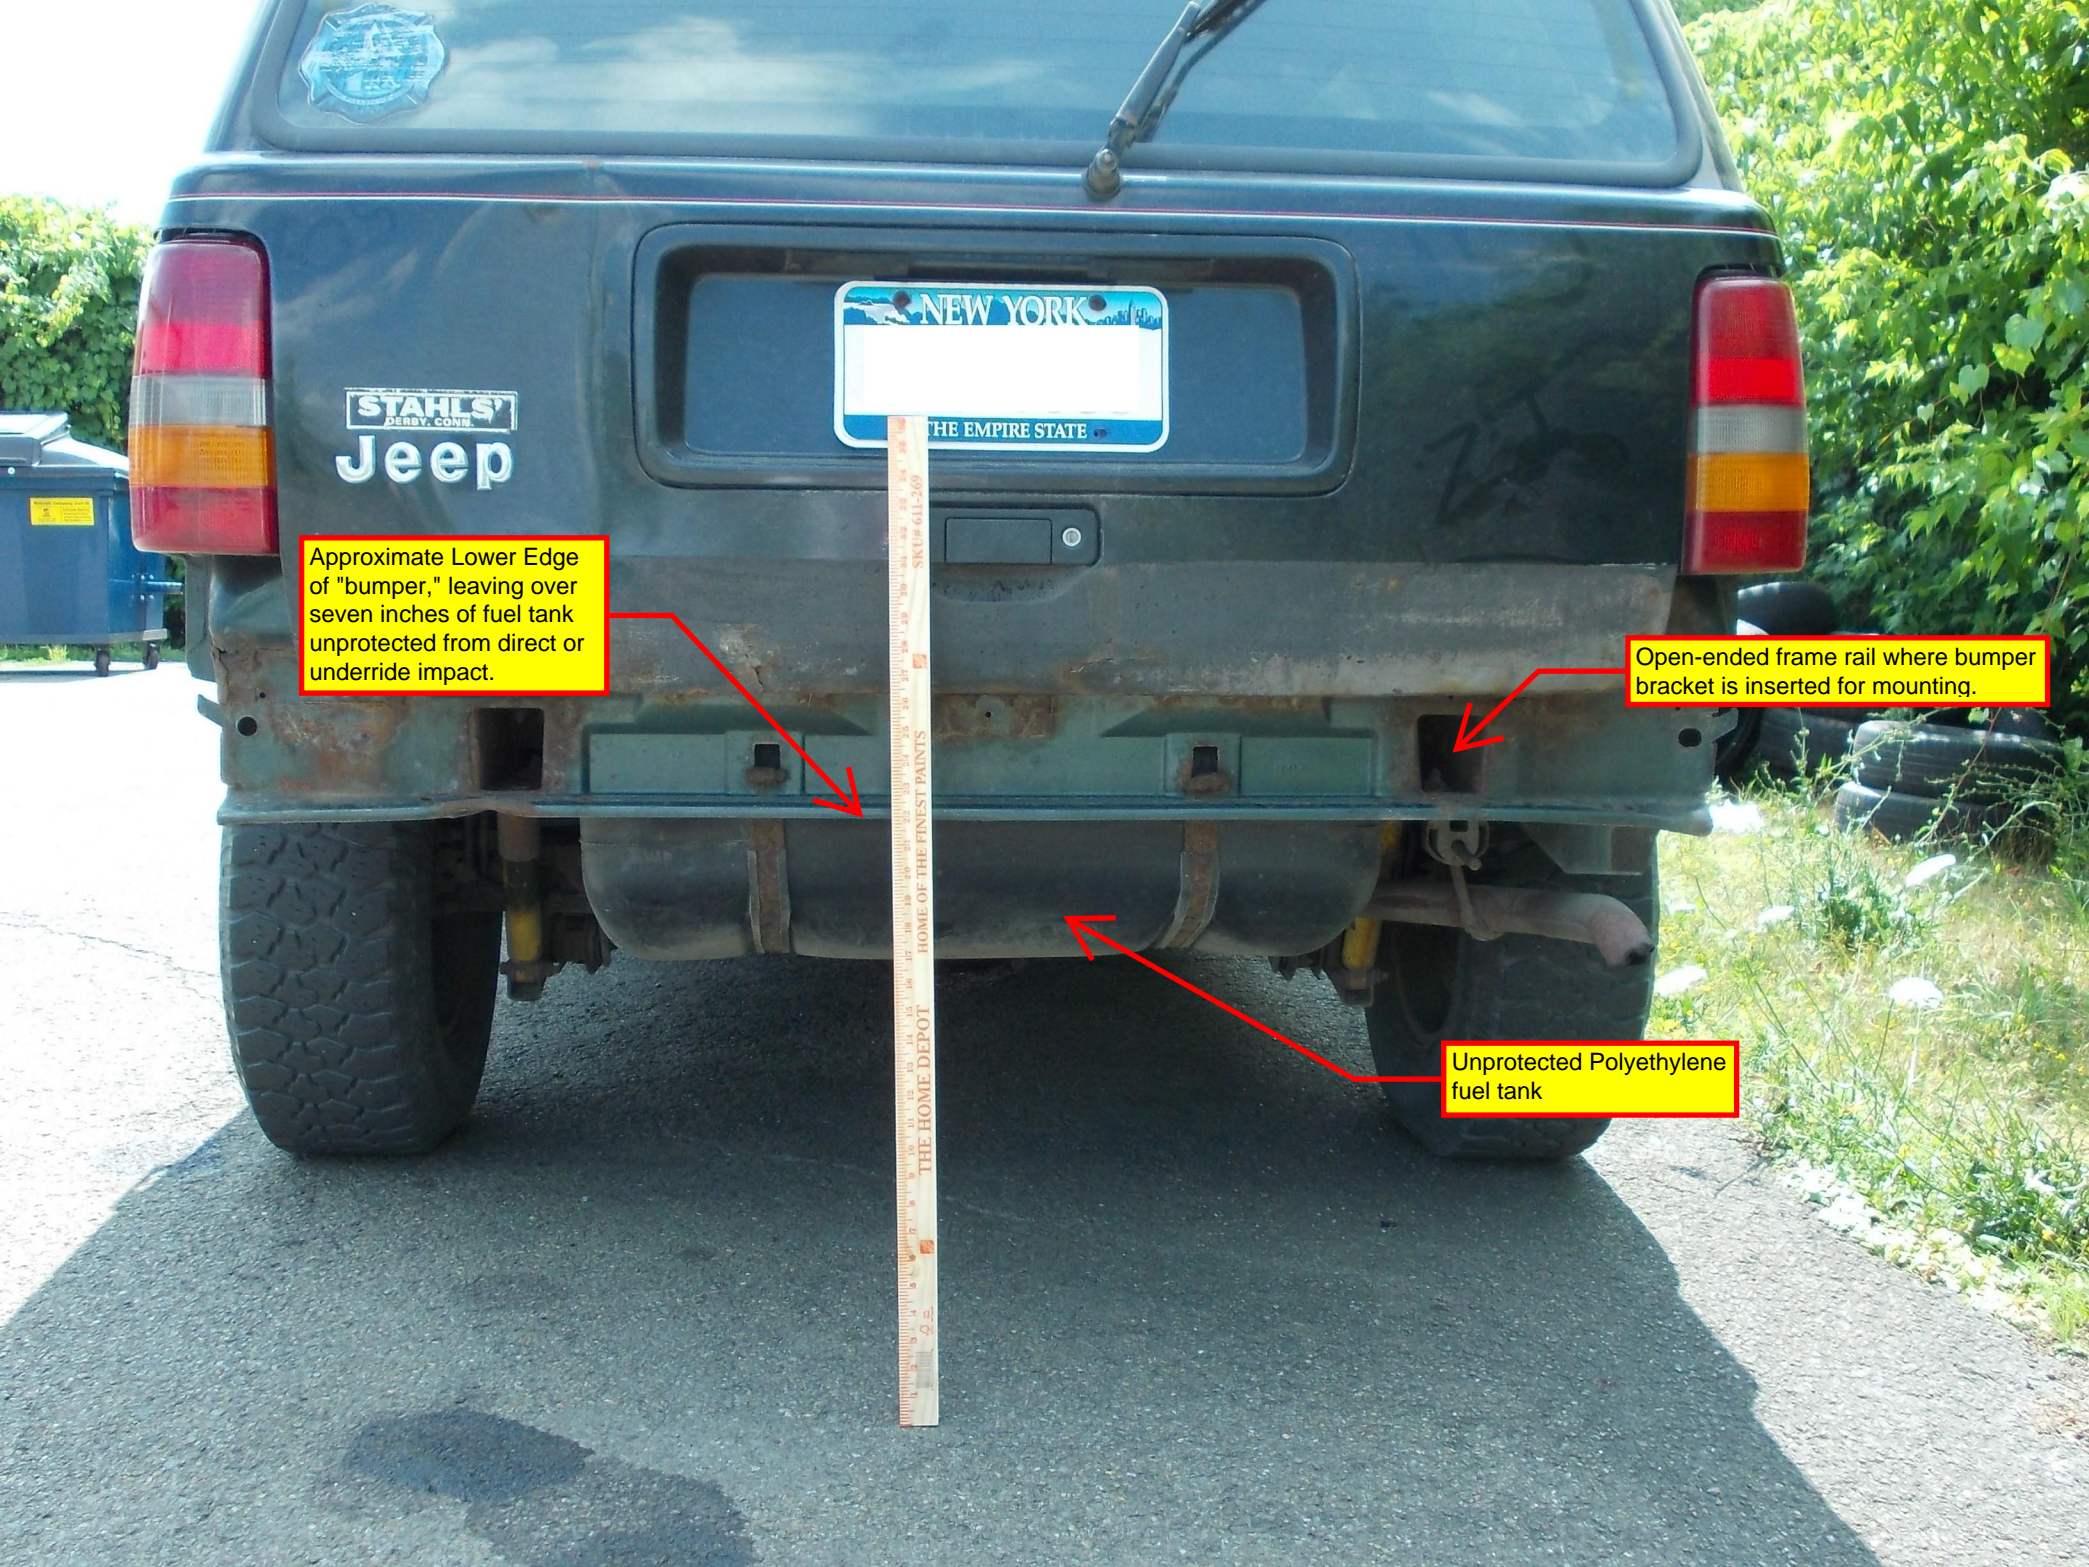
Approximate Lower Edge of "bumper," leaving over seven inches of fuel tank unprotected from direct or underride impact.

Open-ended frame rail where bumper bracket is inserted for mounting.

Unprotected Polyethylene fuel tank

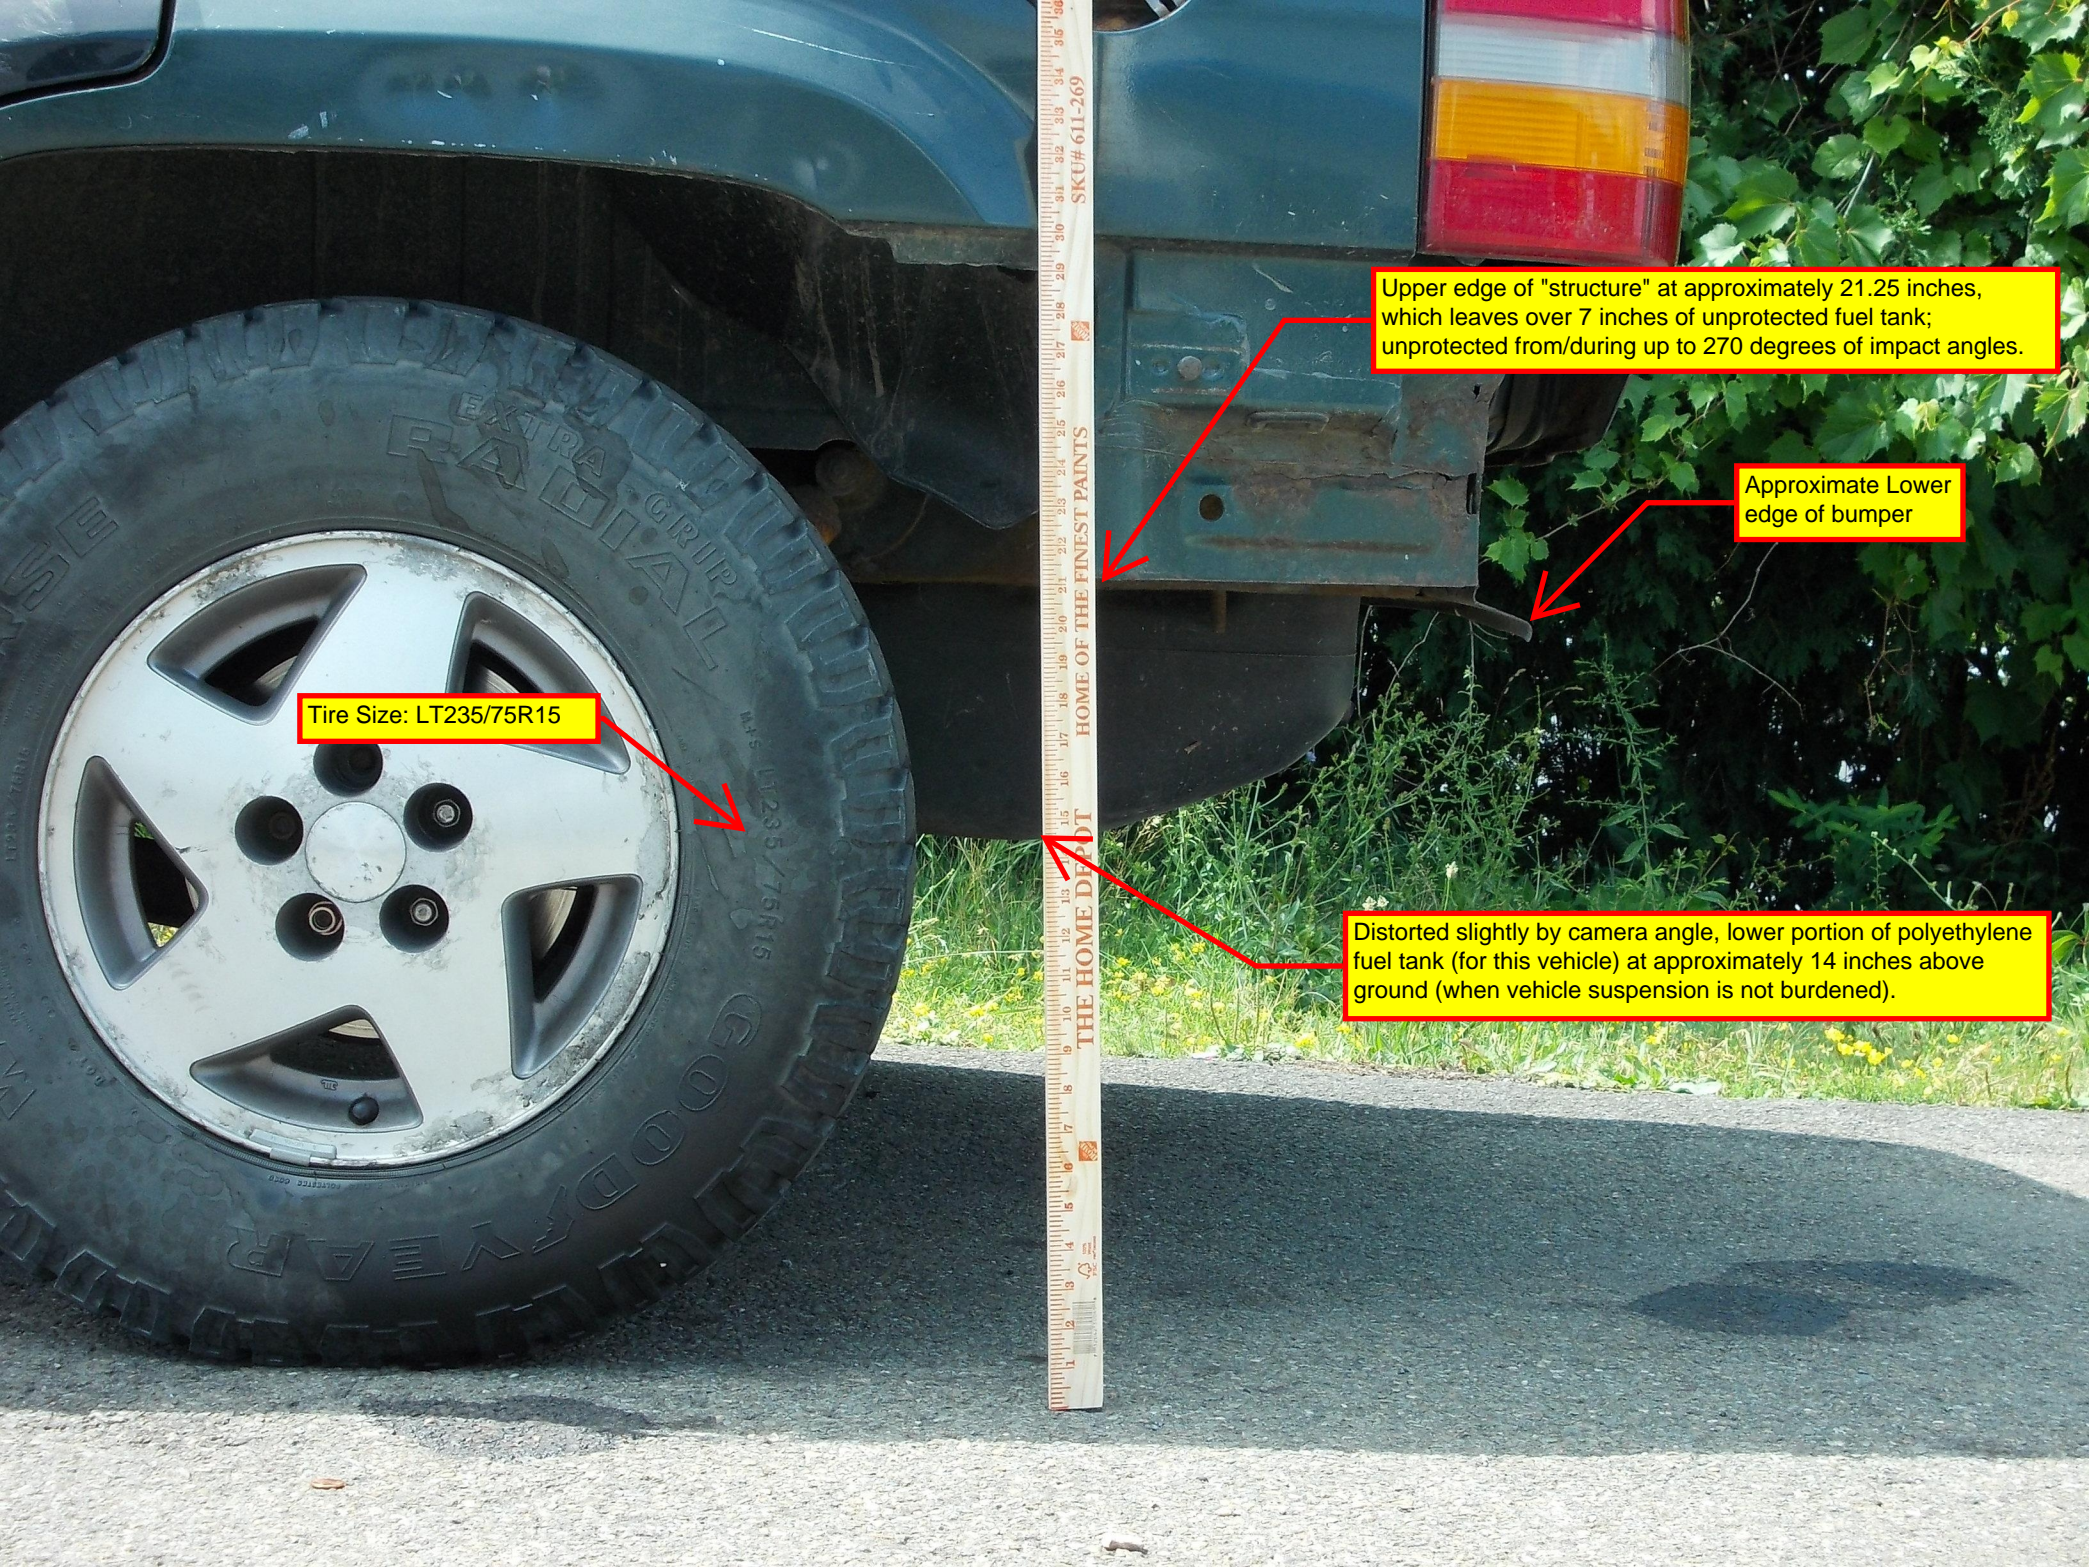
Tire Size: LT235/75R15

Upper edge of "structure" at approximately 21.25 inches, which leaves over 7 inches of unprotected fuel tank; unprotected from/during up to 270 degrees of impact angles.

Approximate Lower edge of bumper

Distorted slightly by camera angle, lower portion of polyethylene fuel tank (for this vehicle) at approximately 14 inches above ground (when vehicle suspension is not burdened).

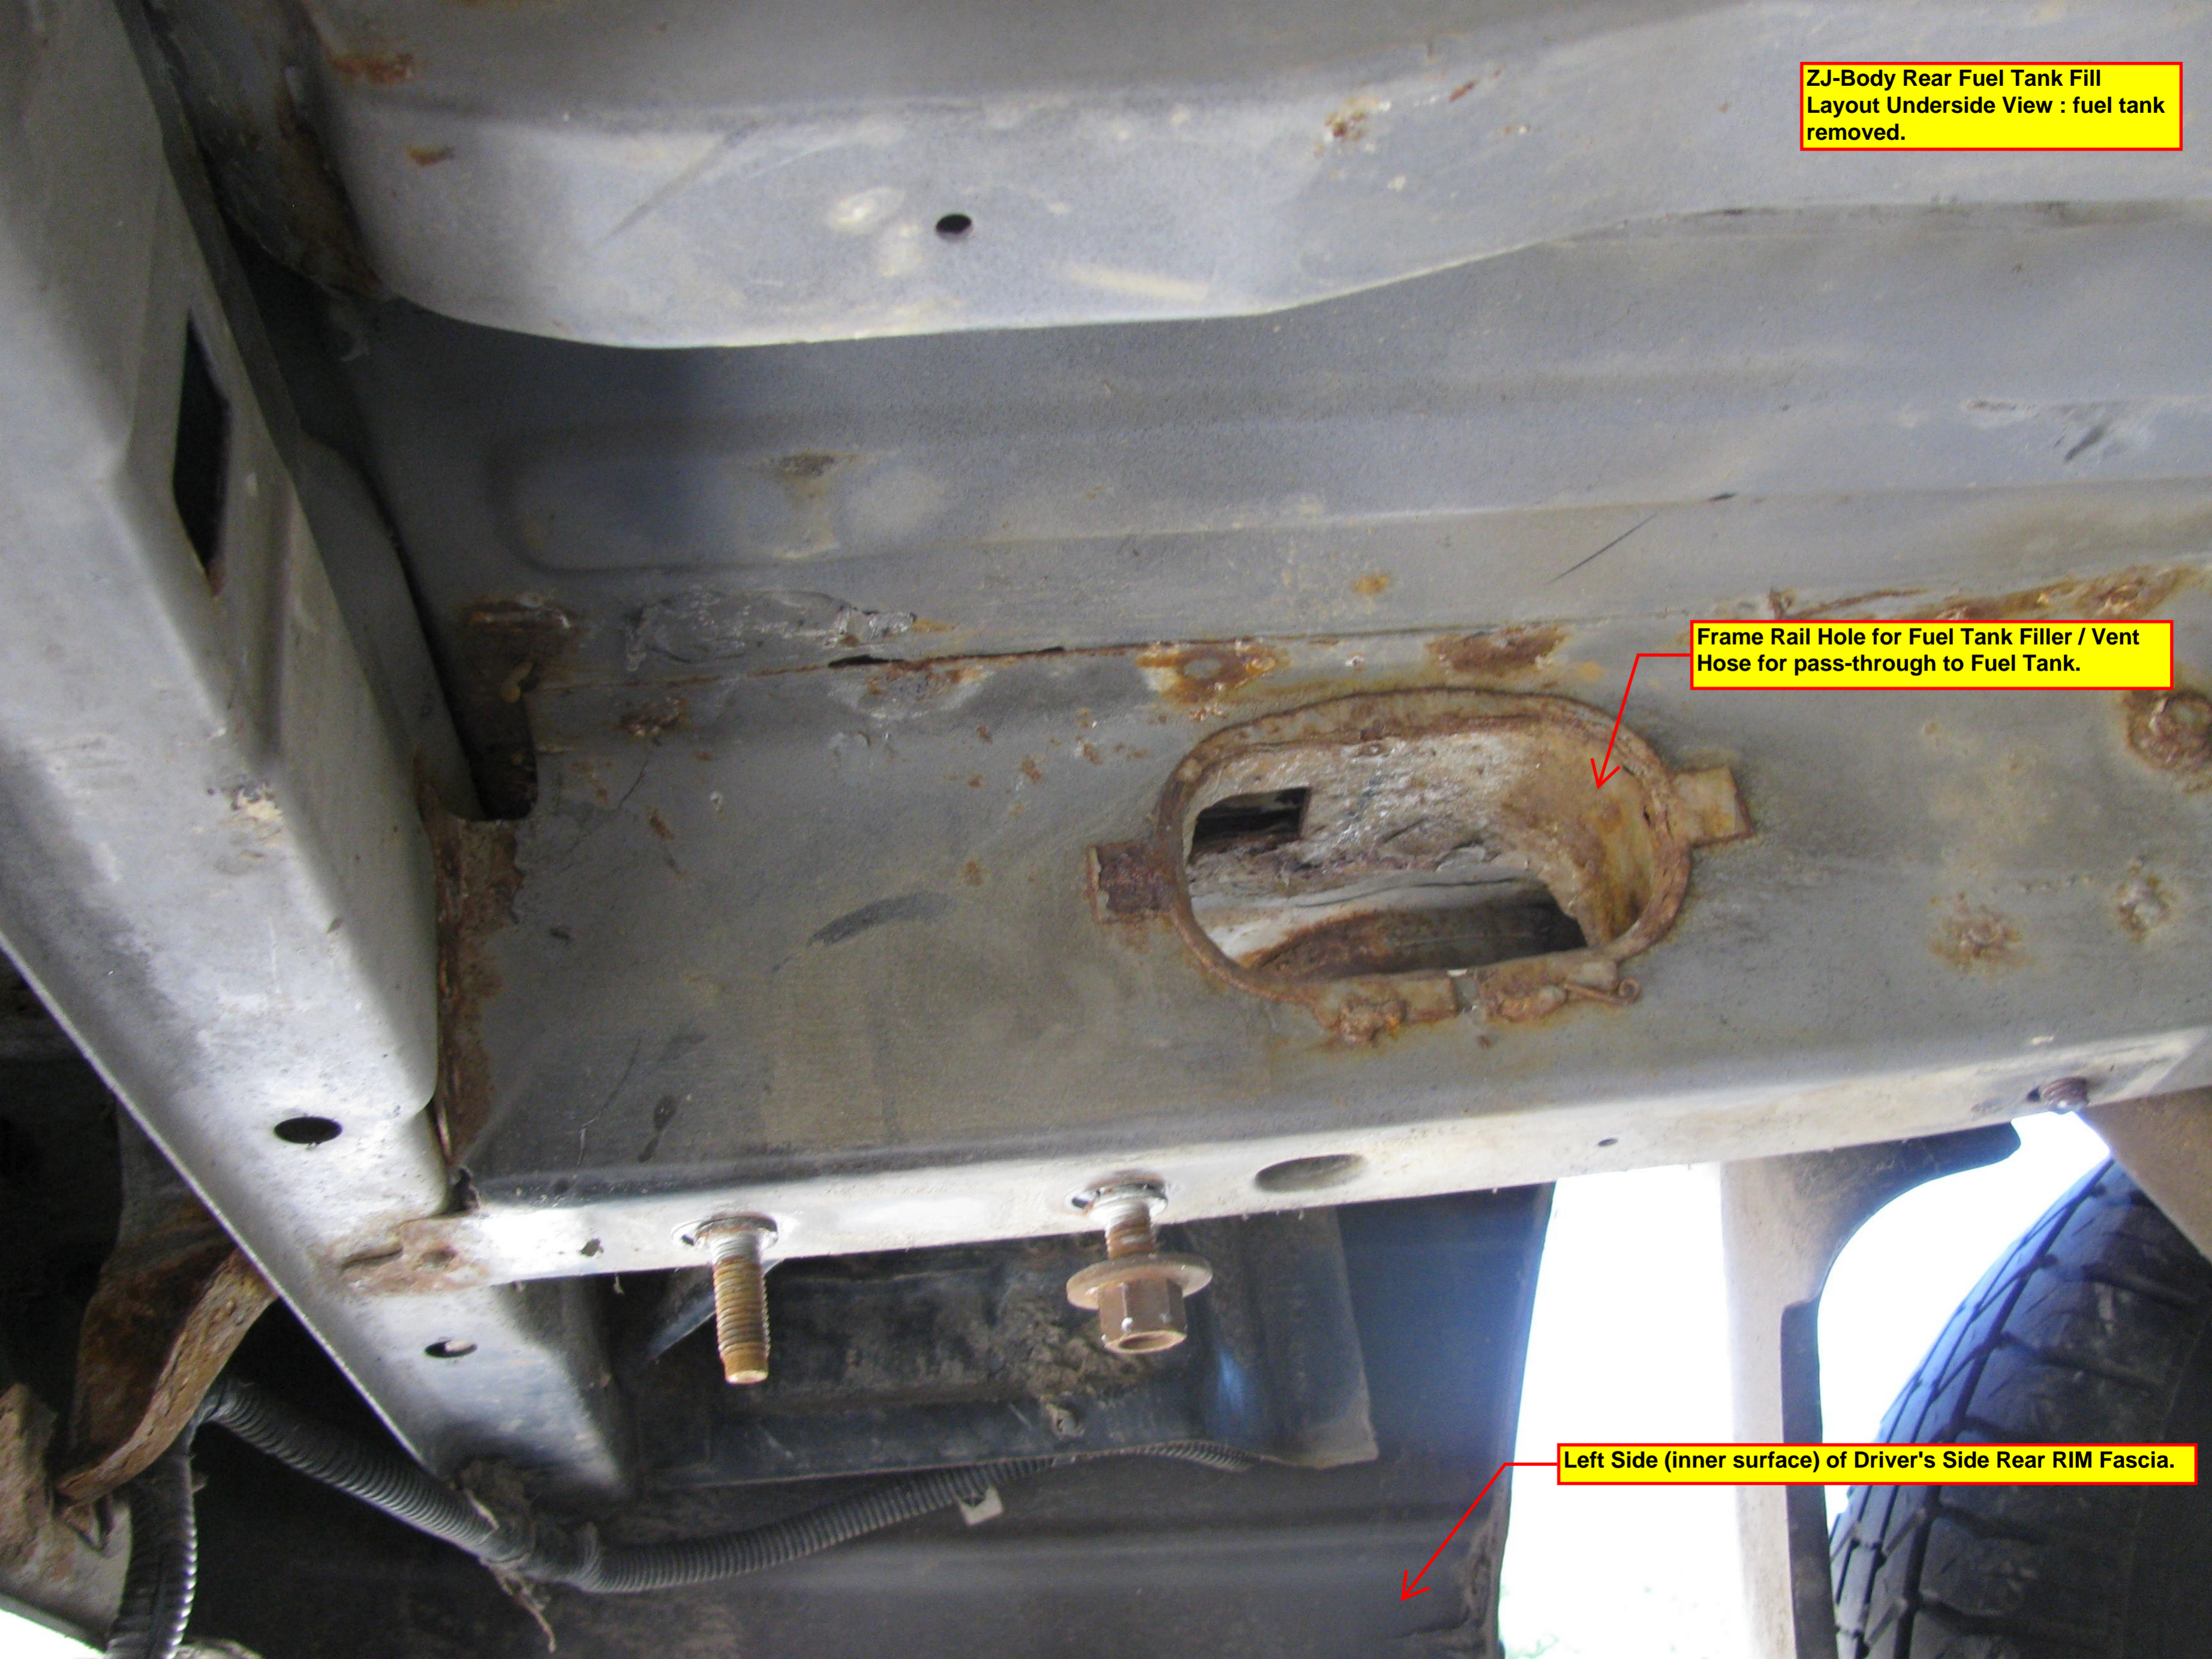
ZJ-Body Rear Fuel Tank Fill  
Layout Underside View : fuel tank  
removed.

Frame Rail Hole for Fuel Tank Filler / Vent  
Hose for pass-through to Fuel Tank.

Left Side (inner surface) of Driver's Side Rear RIM Fascia.

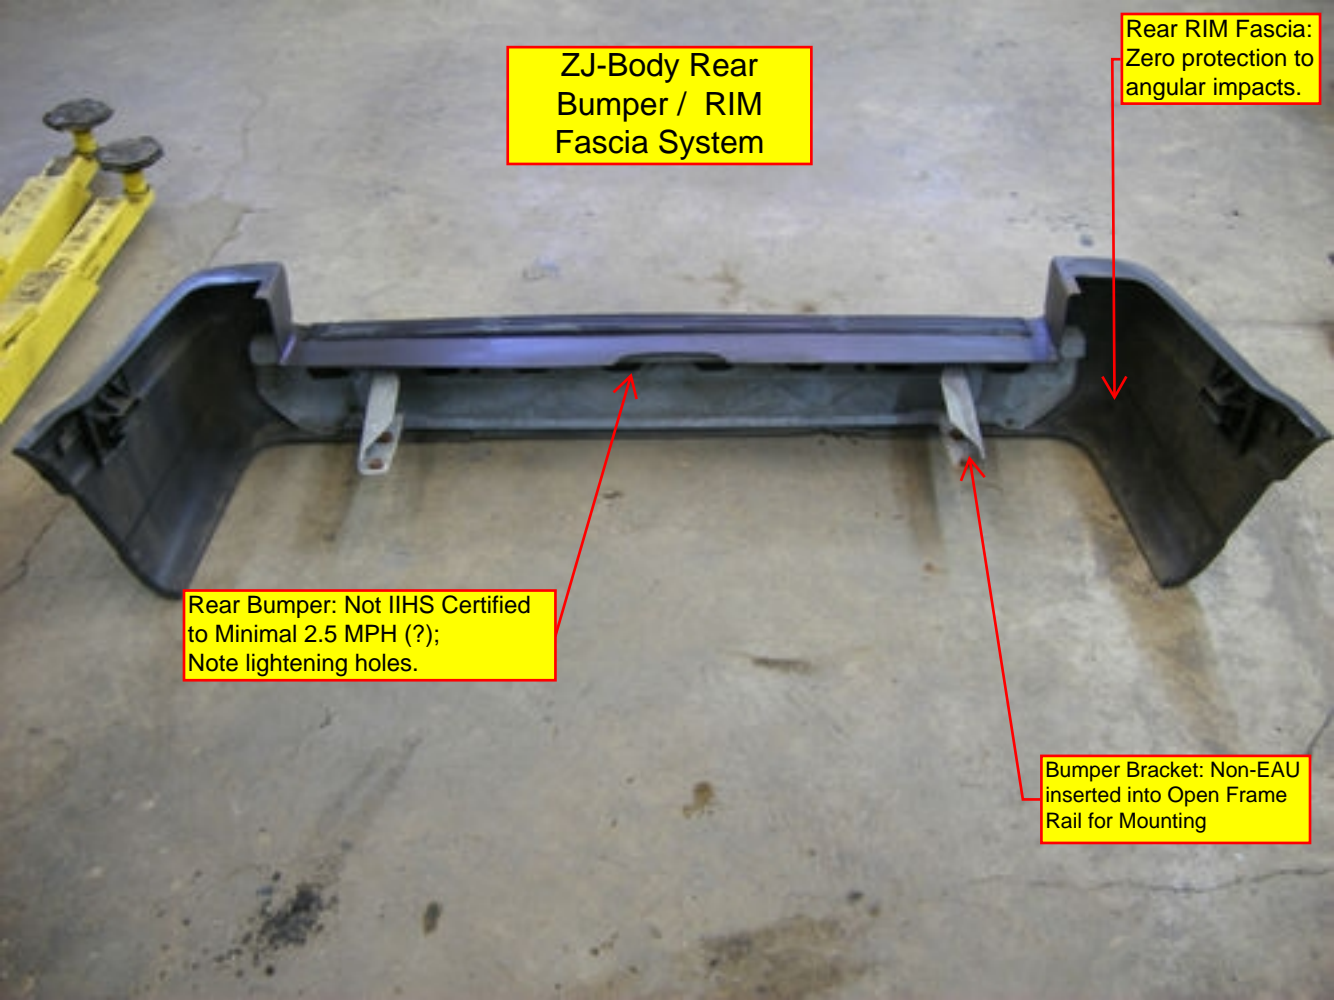
ZJ-Body Rear  
Bumper / RIM  
Fascia System

Rear RIM Fascia:  
Zero protection to  
angular impacts.

Rear Bumper: Not IIHS Certified  
to Minimal 2.5 MPH (?);  
Note lightening holes.

Bumper Bracket: Non-EAU  
inserted into Open Frame  
Rail for Mounting

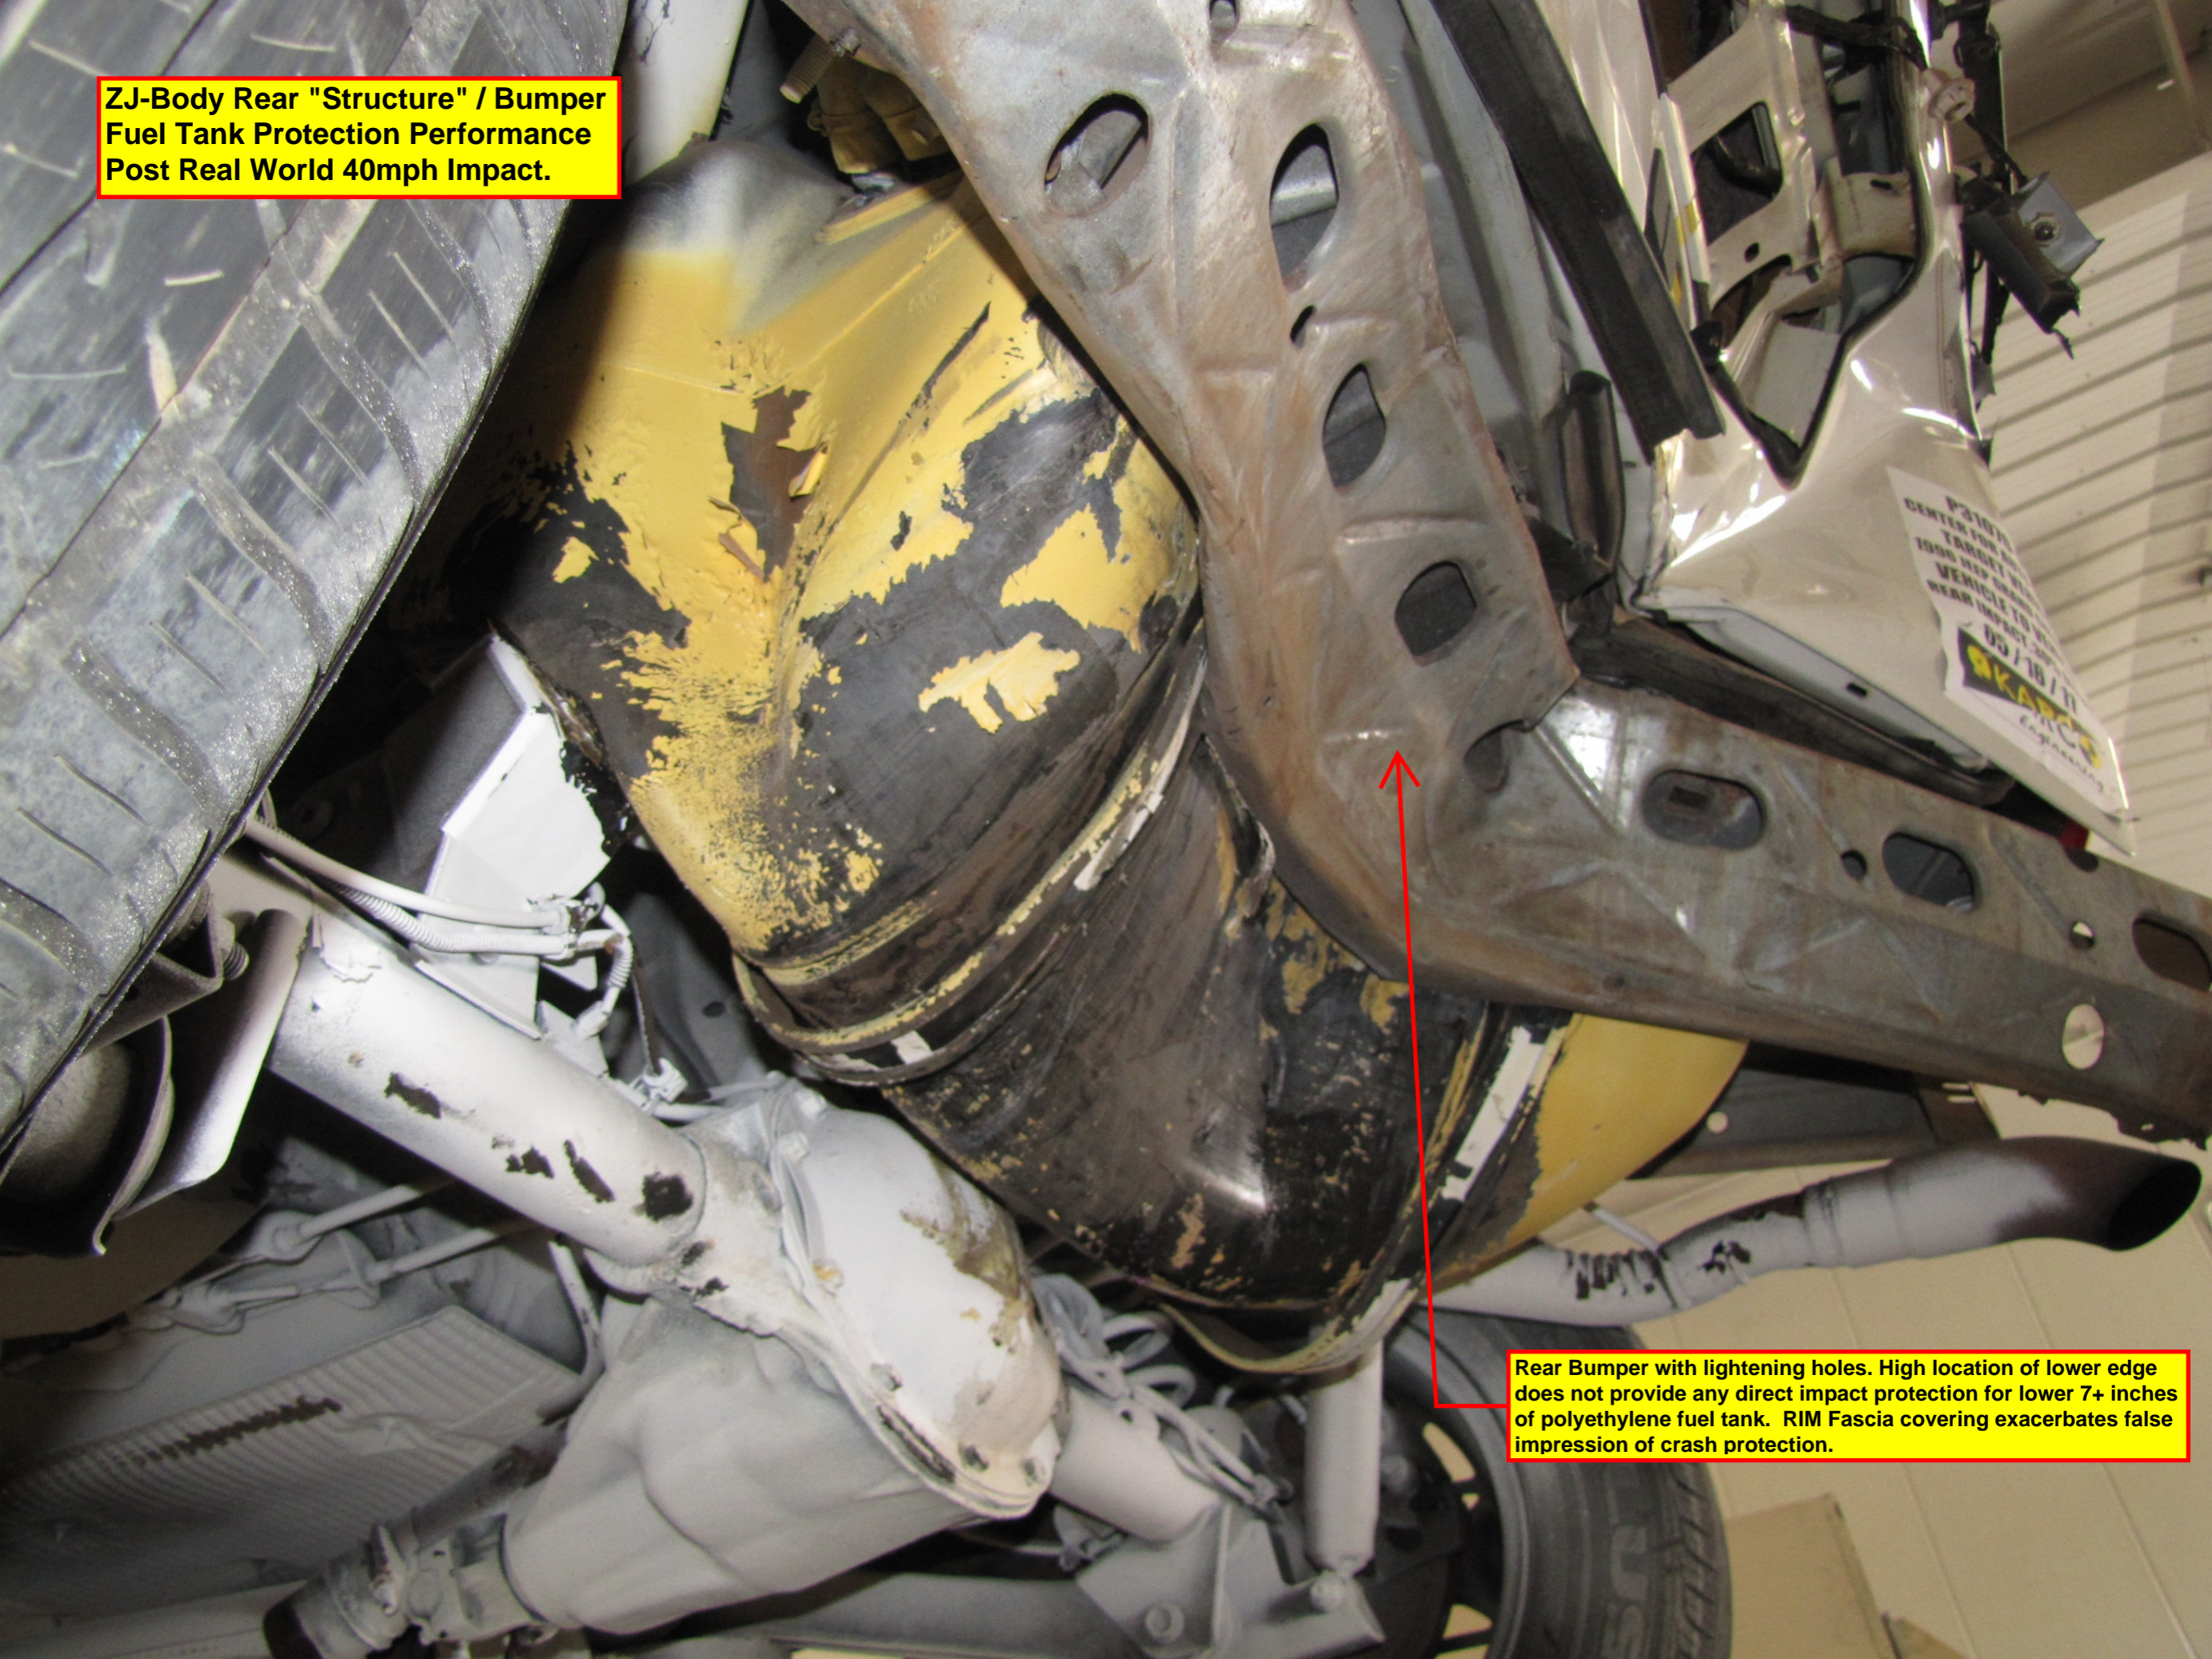
**ZJ-Body Rear "Structure" / Bumper  
Fuel Tank Protection Performance  
Post Real World 40mph Impact.**

**Rear Bumper with lightening holes. High location of lower edge does not provide any direct impact protection for lower 7+ inches of polyethylene fuel tank. RIM Fascia covering exacerbates false impression of crash protection.**

**ZJ-Body Jeep Grand Cherokee Unprotected Fuel Tank System  
Real World Performance of Rear "Structure" and Bumper :  
Post 40mph impact test.**
